# DIVERTING RESERVOIR DAM

## PHASE I INSPECTION REPORT

NY 00056

Name of Dam: Diverting Reservoir Dam  
County and State: Putnam County, New York  
Inventory Number: NY 00056

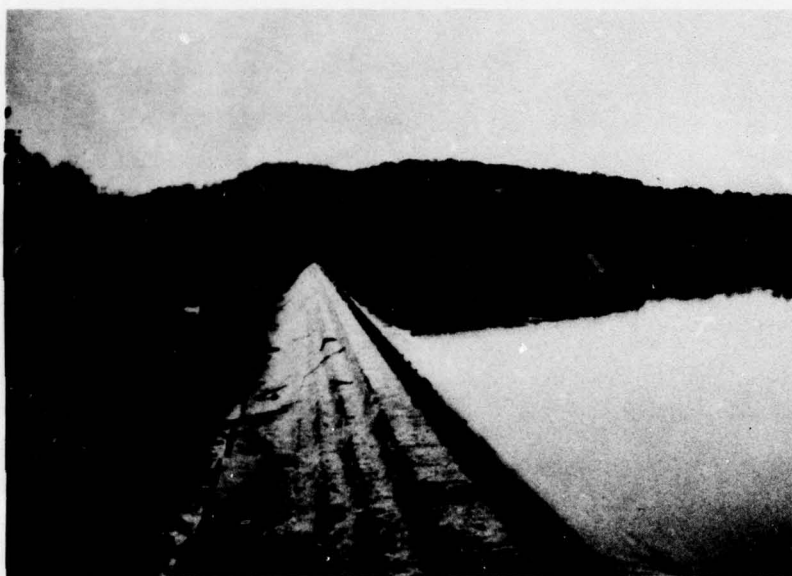
**VIEW OF SPILLWAY LOOKING SOUTHWEST**

b. Dam - The cut stone masonry spillway shows no apparent horizontal or vertical misalignment. The stone blocks have worn less than 1 inch. The silt level appears to be at the spillway crest. A sketch included in an inspection report, prepared by the State of New York, Department of the State Engineer and Surveyor, (no date), shows a rolled earth embankment abutting the upstream face of the masonry spillway (See Figure 5). The northeast abutment of the spillway appears to be in good condition. No serious cracking or spalling of the concrete was observed. The concrete of the southwest abutment of the spillway has undergone surface spalling at several locations. A horizontal crack in the abutment was observed near the spillway crest elevation. The crack is continuous about the visible portion of the abutment. No seepage was observed in the abutment areas. The observed crack and localized surface spalling do not appear to adversely affect the safety of the abutment. An outcropping of what appears to be a tough micaceous gneiss or schist was observed next to the abutment.

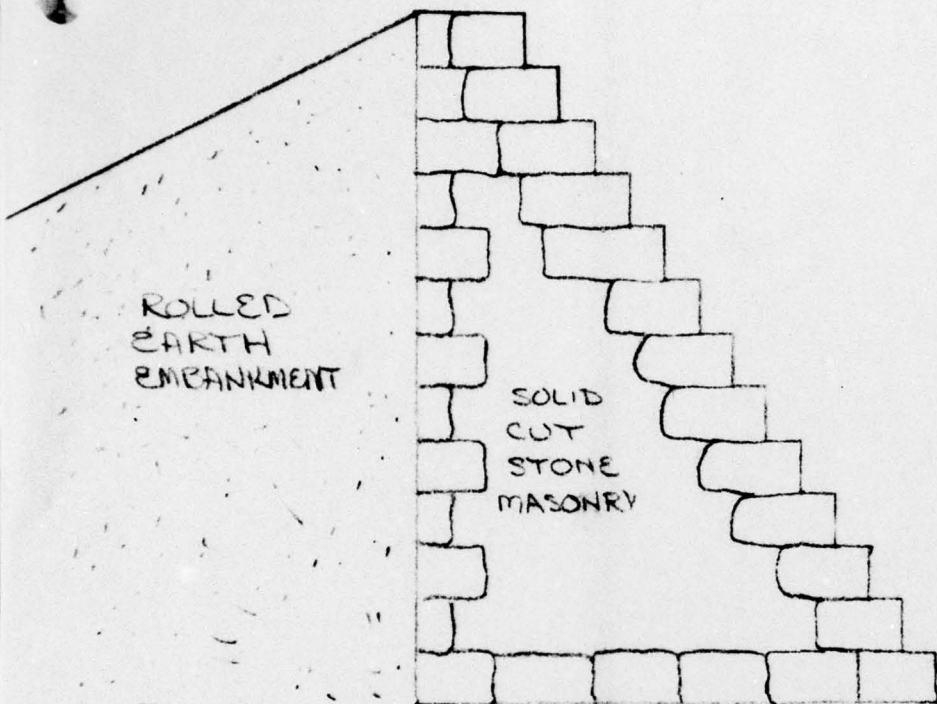
SECTION A-A \*  
(SPILLWAY)

Stability analyses were performed for the spillway section for normal pool, normal pool and earthquake, and the PMF. The foundation reactions were outside of the central third for all analyzed loadings. A synopsis of the results is listed below. Details of the analyses are located in the appendix.

<u>Condition</u>	<u>Factor of Safety</u>		<u>Pressures (psi)</u>	
	<u>Overturning</u>	<u>Sliding*</u>	<u>Heel</u>	<u>Toe</u>
Normal Pool	1.41	7.09	6.25(T)	43.5
Normal Pool & Earthquake	1.35	6.67	9.3(T)	46.6
Probable Maximum Flood	1.09	6.76	17.1(T)	43.3

The gravity overflow section should be strengthened to provide adequate factors of safety for extreme loading conditions. This could be accomplished by making the structure more massive, or by the installation of post-tensioned tendons through the structure.

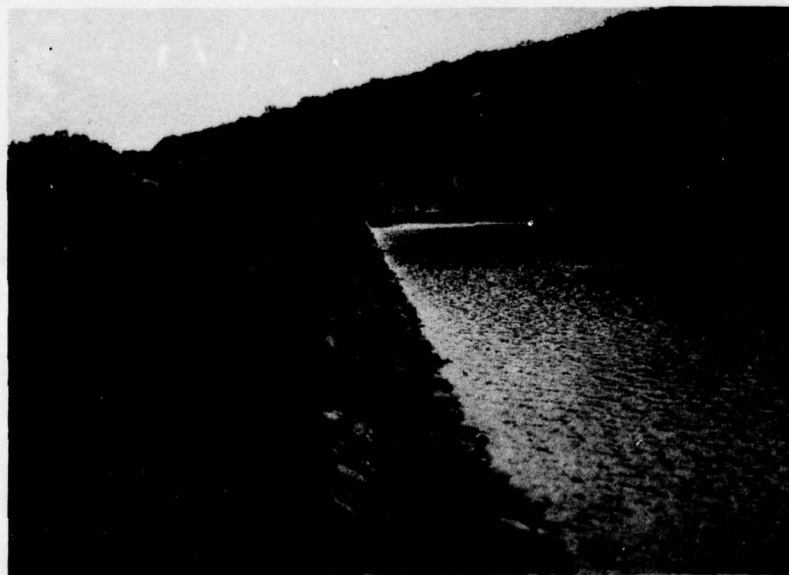
UPSTREAM SLOPE OF EARTH EMBANKMENT

Riprap is in excellent condition.
